Post Conflict Socio-Economic Recovery of a Disaster Affected Society by Timely Engineering Intervention of Restoration of Blasted Kalmadu Irrigation Scheme with Environmental Mitigation Measures

S.S.Sivakumar

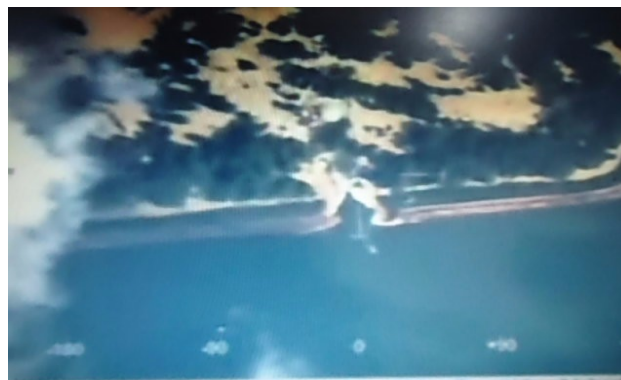
Fig.1.1 Time of blast of Kalmadu Scheme in January 2009

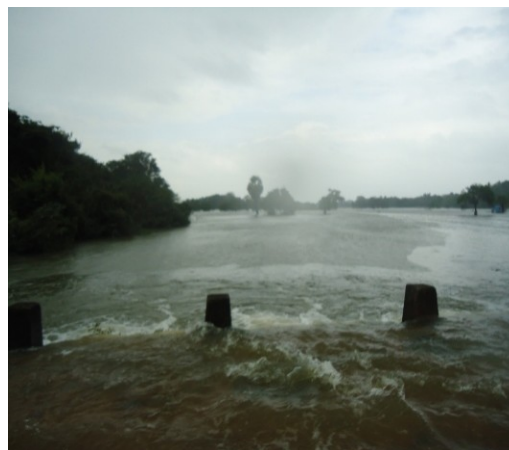
Fig 1.3. When breach occurred

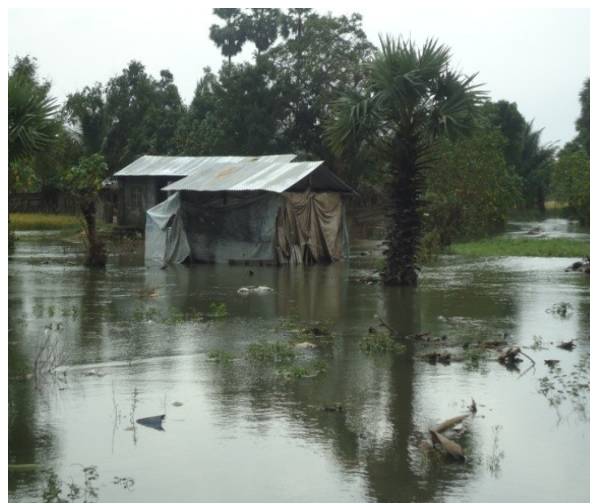
Fig 1.4. After breach occurred

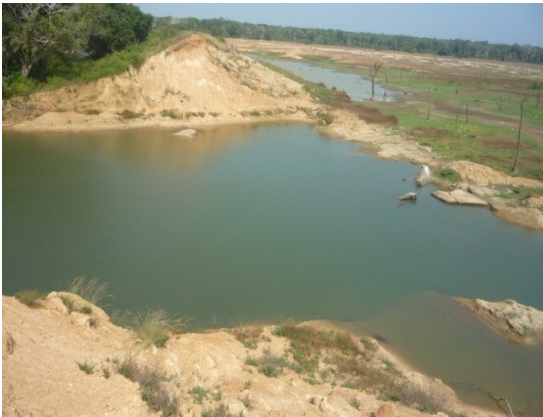
Base line investigation was done collaborating with Irrigation Department Northern Province and it was identified that the maximum length of breach is 125 m and 15 m depth scour was formed in the breached section and 17 m filling with 90,000 m³ was used to rebuild the breached section.

Fig 3.1 breached section of the dam

Observations made and Repair needs	Plan adopted during Implementation
1. Placement of coffer dams in both u/s and d/s area of the breached sections keeping adequate space for foundation excavation and repair works. Dimensions are to be determined after taking measurements and construction drawings.	Coffer dam axis and cross section was changed for u/s and d/s, leaving adequate space for repair works. Estimate was revised to accommodate this.

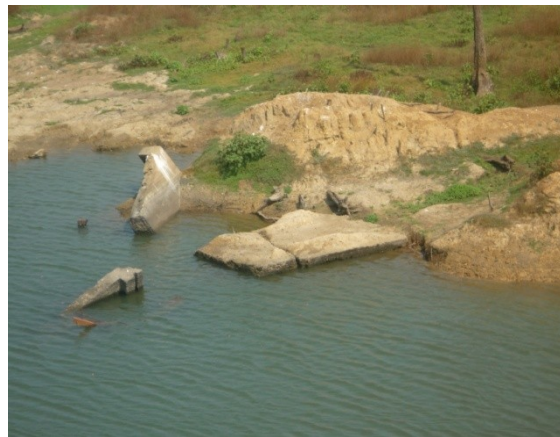
Fig 3.2 Part of the washed off sluice

4. Replacement of a new sluice/outlet works instead of damaged one is planned to place on the left area of the breached section. Foundation investigations of the selected location are vital to design the sluice.	This task was given to NBRO and based on their findings design was done by the design engineers with the help of DD (Design) and constructed accordingly.

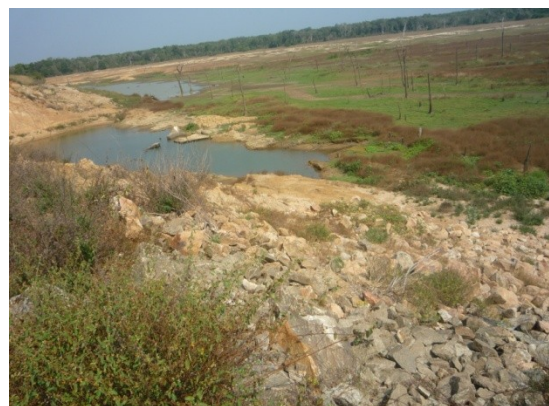
Fig 3.3 washed off section of the Rip-rap

2. Gravel layer to be placed and compact before placing rip-rap	This suggestion was incorporated in the specification.
3. Introduce the rip rap up to the top of the bund level is the present day's requirement, which has been accepted by ID considering stability and environmental conditions.	This suggestion was incorporated in the estimate.

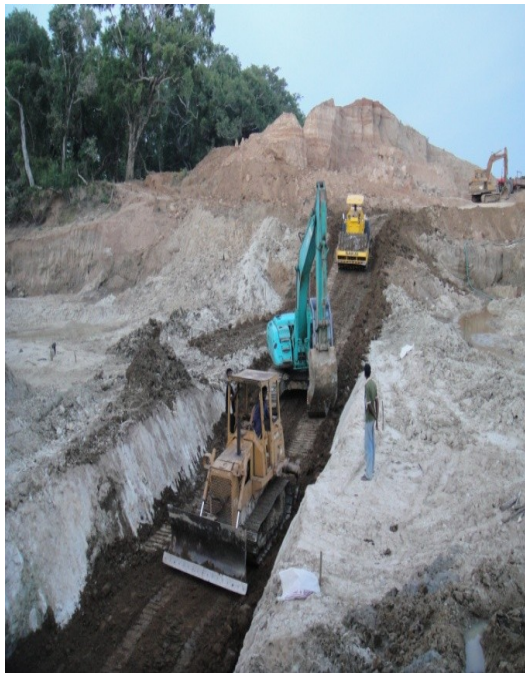
Fig 7.3 Trench filling across the bund section

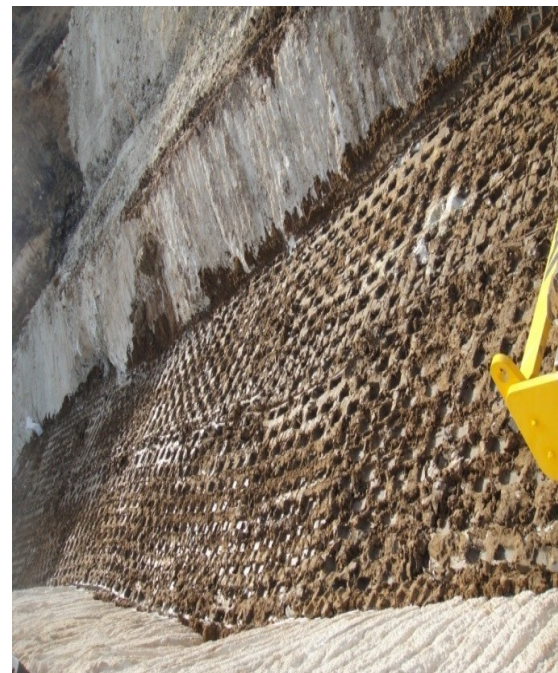
Fig 7.4. Trench filling across the bund section

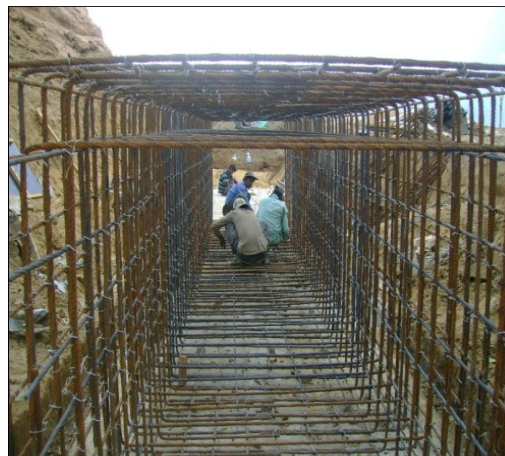
Fig 7.5. Sluce barrel construction

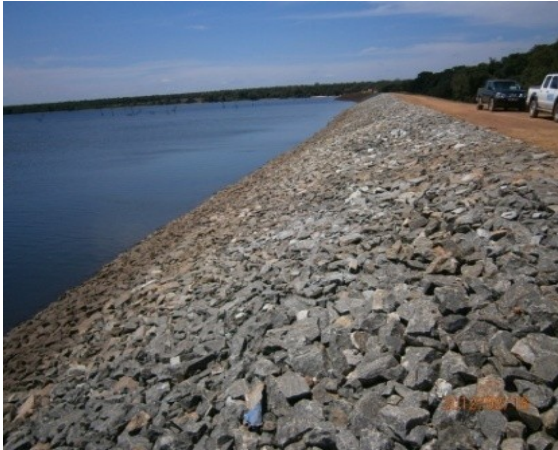
Fig 7.6. Completed u/s embankment

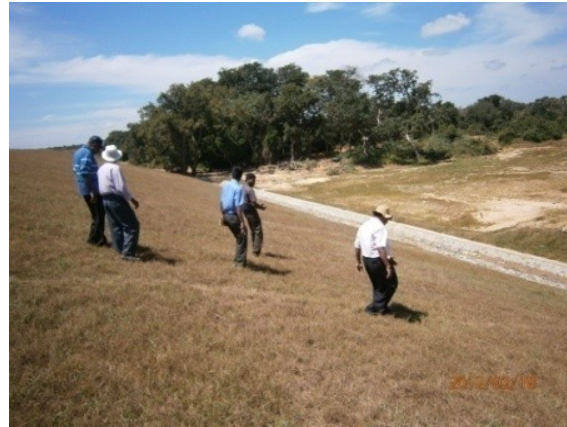
Fig 7.7. Completed d/s embankment

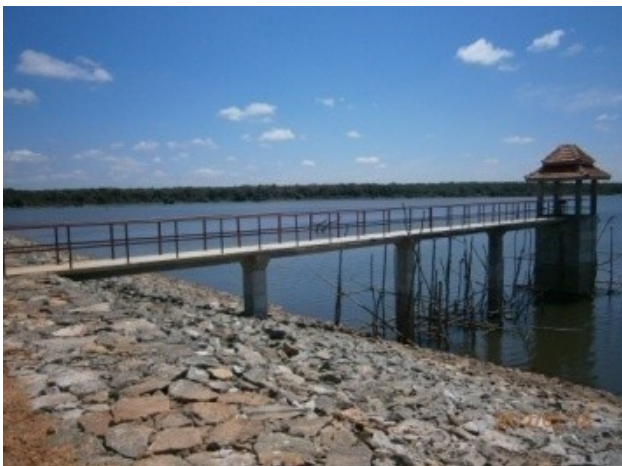
Fig 7.8. Completed sluice

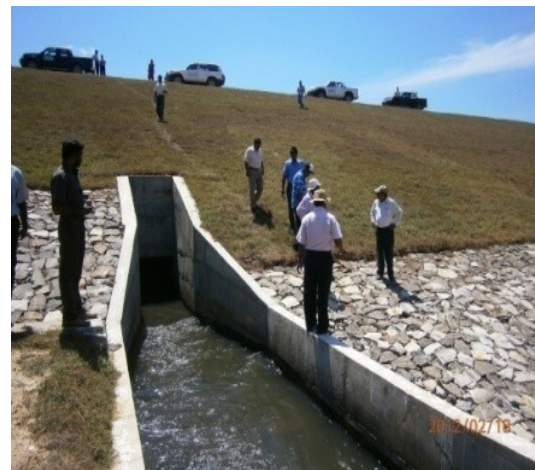
Fig 7.9. Sluice outlet transition and toe area
