*International Journal of Development Research*  
Vol. 5, Issue, 06, pp. 4570-4576, June, 2015

### **PRELIMINARY ASSESSMENT AND SPATIAL DISTRIBUTION OF SELECTED WATER QUALITY PARAMETERS AT KALMADU TANK IN VAVUNIYA DISTRICT OF SRI LANKA**

This research on Kalmadu tank aims to analyze the horizontal and vertical profiles of selected water quality parameters. Twenty randomly selected sampling points on surface and corresponding vertical depths of 30 cm and 60 cm were measured for temperature, pH, TDS, EC and ORP using intended electronic probes. The measured values were statistically analyzed with t-test, paired t-test and Pearson correlation. Kriging interpolation technique was used to visualize the spatial distribution. Results revealed non-compliance of TDS and EC with existing permissible limits for irrigable water. Except the temperature with pH, all the other measured parameters resulted positive correlation and TDS trend resembled the spatial pattern of EC. The mean values of pH at 30 cm & 60 cm depth significantly differed with surface, similarly surface ORP varied from 30 cm depth. There are no significant vertical wise changes observed in the other tested parameters. Signi

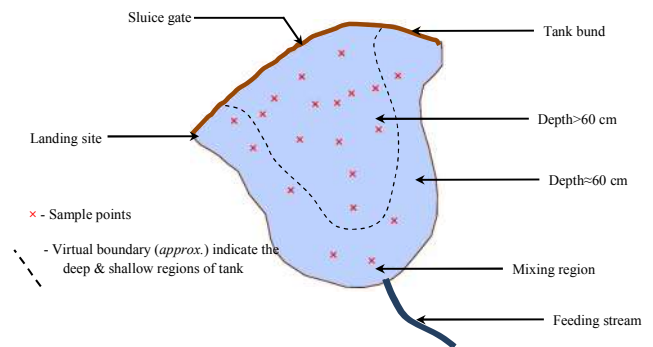
Altogether 20 sampling points were randomly selected approximately proportionate to the tank shape from Kalmadu tank using Google Earth Pro before the field investigation (Figure 2). The sampling activity was conducted during September of 2014 which is the dry season of this district. The maximum tank water level measured was 1 m.

Figure 2: Kalmadu tank description and sample locations in drought season

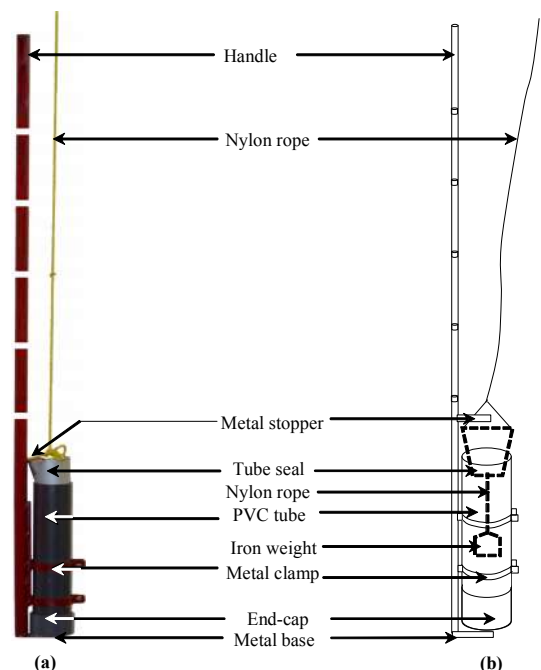
Figure 3: Simple water sampler used at Kalmadu tank to sample at different depths (a) actual photograph (b) line diagram

A water sampler was designed in a manner to lock the water at required depth. The high density PVC bottles were used for collecting water, while steel attachment serves as a handle.

The equipment was marked with graduated scale in order to ensure that the sample was collected at a set depth. The functions of the each parts of the water sampler is briefly described below.

| <b>PVC tube</b> | : Collect and holds the sample water |
| <b>Tube end-cap</b> | : Used to seal the tube bottom |
| <b>Metal base</b> | : It holds the PVC tube |
| <b>Metal clamps</b> | : Helps to holds the PVC tube vertically |
| <b>Tube cap or seal</b> | : Prevent the water penetration when submerged |
| <b>Iron ball/weight</b> | : Helps to seal the PVC tube when there is no force on rope |
| <b>Nylon rope</b> | : Used to connect to pull the tube cap and iron ball |
| <b>Upper metal stopper</b> | : Limits the further movement of tube cap |
| <b>Handle</b> | : Stiffly support the sampler portion and contains scale which helps to lower to the desired depth. |

In addition to the surface, samples were collected at vertical depths of 30cm and 60 cm from the surface. Sampling equipment was devised for the water sampling at Kalmadu is shown in Figure 3.

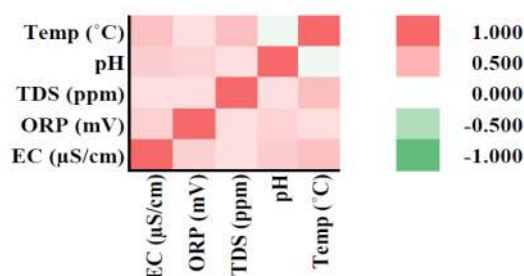
A correlation analysis was performed as a preliminary descriptive technique to understand the systematic changes in the value of one variable accompanied by systematic changes in the other (Wijesekara, et al., 2014). Figure 4 shows the graphical representation of pair-wise Pearson correlation between the measured parameters.

**Figure 4: Pair-wise correlation coefficient plot for the measured water quality parameters**

It was found that except Temperature with pH, all the other measured parameters have positive correlation in between them. At the same time the matrix implies a negative correlation between temperature and pH. From Figure 5, it is possible to presume there are changes in individual water quality parameters along the depth. Also the relationship was found to be positive ranging from 0.12 to 0.98 (Pearson correlation coefficient (r)). Especially it was found TDS and EC were same in terms of trend, but both values decreasing with depth. EC is an indirect measure of TDS in water bodies and usually the conversion factor ranges between 0.48 and 0.86 depending on the unique mixture of materials dissolved in the water medium (Niekerk, et al., 2014). The conversion factor was calculated by dividing the TDS ( $\text{mg L}^{-1}$ ) by EC ( $\mu\text{S cm}^{-1}$ ) and it was found to be 0.50 for the Kalmadu tank. This value lies within the ranges mentioned in various literatures for fresh water (Ali, et al., 2012; Atekwana, et al., 2004; Niekerk, et al., 2014).

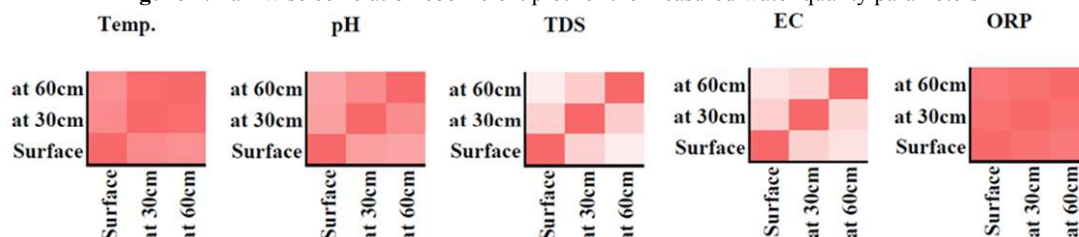
**Figure 5: Individual pair-wise correlation coefficient plot for Temp., pH, TDS, EC and ORP**

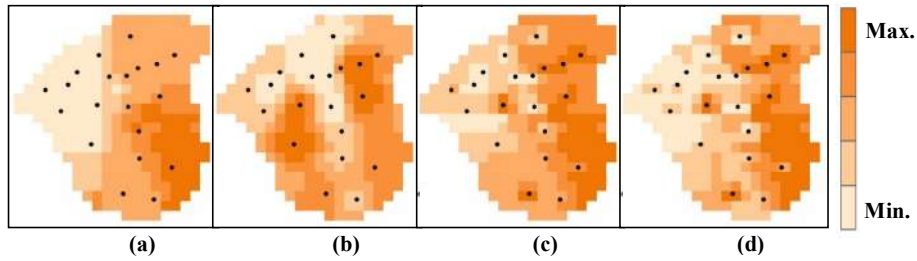
**Figure 6:** Temperature profile (a) Overall (b) surface (c) at 30 cm depth (d) at 60 cm depth

Along all the depths, relatively lower temperature was observed near the landing site. The same trend is prominent with considered depths (Figure 6). The observed temperature profile may be due to the reflection and shade of floating and submerged aquatic plants exist at Kalmadu tank. Adjacent to the mixing region on the surface (just after the feeding stream), the observed pH was relatively low when comparing with other regions. Same pattern was observed throughout the measured depths too (Figure 7).

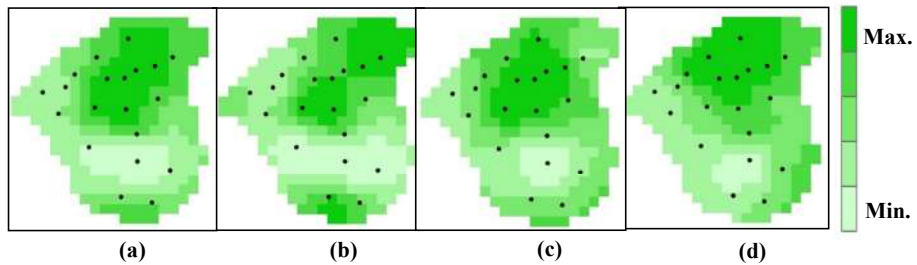
**Figure 7:** pH profile (a) Overall (b) surface (c) at 30 cm depth (d) at 60 cm depth

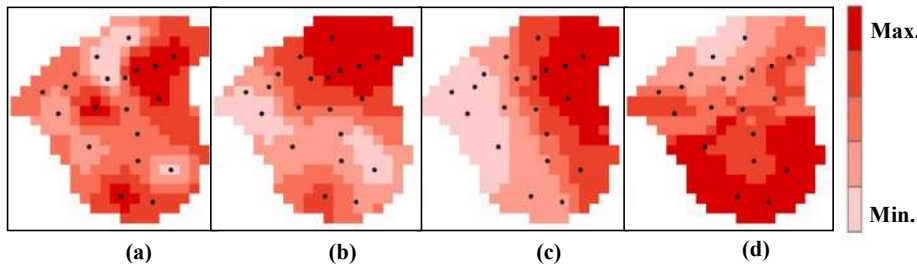
**Figure 8:** TDS distribution (a) Overall (b) surface (c) at 30 cm depth (d) at 60 cm depth

This may be due to the microbial organic degradation process (which releases acidic chemicals) and presence of aquatic plants. Adjacent to the tank bund, relatively higher TDS was observed near the surface (Figure 8). It may be due to the anthropogenic usage of water. In addition to this 60cm depth samples were detected with higher TDS values in mixing region (Figure 8(d)). It could be due to the small currents movements towards the tank from feeding stream which may have disturbed the bottom of the tank.

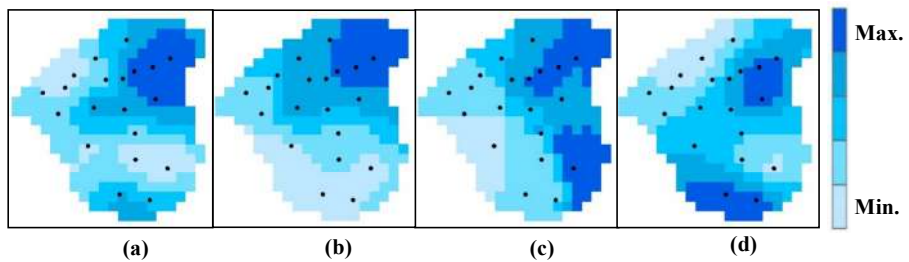
**Figure 9:** EC profile (a) Overall (b) surface (c) at 30 cm depth (d) at 60 cm depth

Depth wise changes of EC values nearly resembles the TDS profile (Figure 9), i.e. higher EC values were observed near the tank bund for surface samples and near the mixing region for 60 cm samples (Figure 9(d)). In the mixing region where the shallow water exists, ORP was observed to be high than the other regions (Figure 10). It may be due to the higher DO (Dissolved Oxygen) level thus increase aerobic microbial organic degradation (Drever, 1982). It also should be noted, the regions in which ORP was high, it is possible to observe the acidic pH.

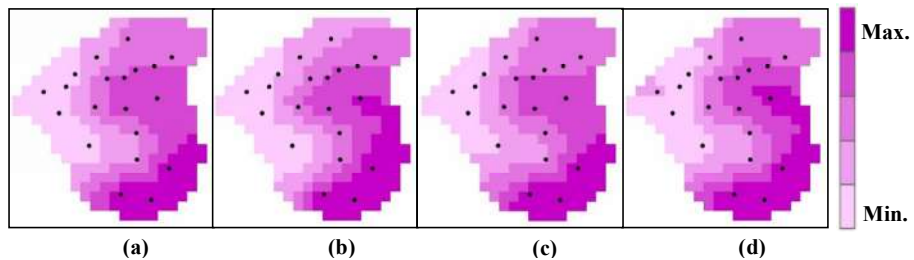
**Figure 10:** ORP profile (a) Overall (b) surface (c) at 30 cm depth (d) at 60 cm depth
