Impact Of Seawater Intrusion Bund On Soil & Water Conservation Along The Coastal Line Of Poonakary, Sri Lanka

Abstract – Saltwater intrusion into coastal aquifers is reported at coastal region of Poonakary, Kilinochchi district. A sea water intrusion bund was constructed by United Nations Development Programme in 2015 to reduce the issues with seawater intrusion. This study aimed to measure the variations of soil salinity and pH before (2015), just after (2016) and three years after (2018) the construction of bund and to identify the impacts of seawater intrusion bund on soil, water quality and crop improvement in the area. The study was conducted in three selected Grama Niladari Divisions of Poonakary, during July to September period in 2018. Soil samples were collected from 30 locations at different sampling depths and the locations were recorded by using GPS and fifteen water samples were collected to measure the water quality parameters and the values compared with WHO standards. A questionnaire survey was conducted to assess the crop improvement in the selected locations. When comparing the soil pH in 2016 and 2018, at all depths except 60cm, changes were highly significant a

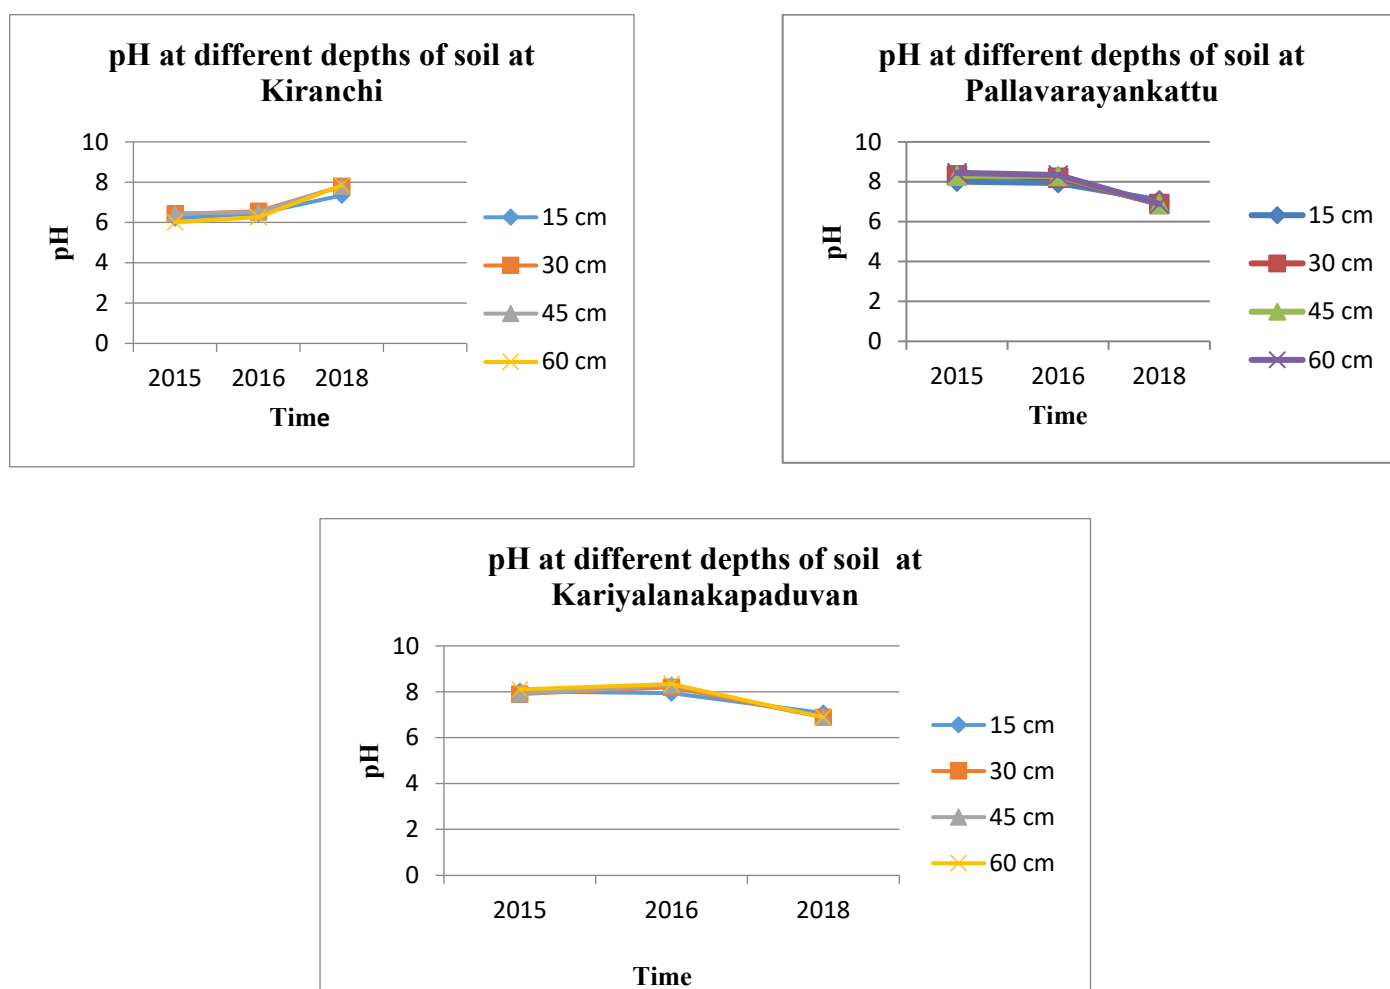
Figure II: Changes of soil pH with different soil depths at three selected locations

The Fig. II shows the changes of soil pH mean value with different soil depths in 2015, 2016 and 2018 at selected locations. When comparing the pH mean values of all three locations in 2016 & 2018, in 2018, at 15cm depth the mean pH value ranged from 7.07

– 7.81 and at 30cm depth it varied from 6.89 – 7.8 and at 45cm depth it was 6.89 – 7.8 and at 60cm depth it was 6.89 – 7.85. The result revealed that the pH values were closer to neutral pH. When compared to other two locations at Kiranchi, the pH values were slightly acidic in 2015 & 2016. Because of its lower elevation (approximately 0 - closer to sea), soil erosion was high. Due to soil erosion slightly acidic soil pH was observed. The bund constructed stoped the velocity of surface run off water and improved deep percolation. So that gradual improvement of soil pH was observed from 2015 to 2018. According to Osman Ardahanlioglu *et.al*, (2002), in Turkey, the variation of salt affected soil study revealed that the soil pH at 0- 30cm depth was 8.1 ± 0.8 and at 30-60cm it was 8.2 ± 0.7 . But in this study the obtained values in the year 2018 were lesser than the referred values. Therefore, it is clearly obvious that there is an improvement in soil pH in 2018 due to the bund.

Table III shows the result of “Paired T test” for the effectiveness of bund on soil pH in 2016 & 2018, revealed that soil pH at 15cm, 30cm and 45cm are highly significantly different ($P < 0.01$) just after and three years after the construction of bund. At the depth of 60 cm, there is significant change ($P < 0.05$) observed. When comparing the mean values of pH in 2015 at different depths, it was revealed that, in 2016 and 2018 the soil pH was closer to neutral.

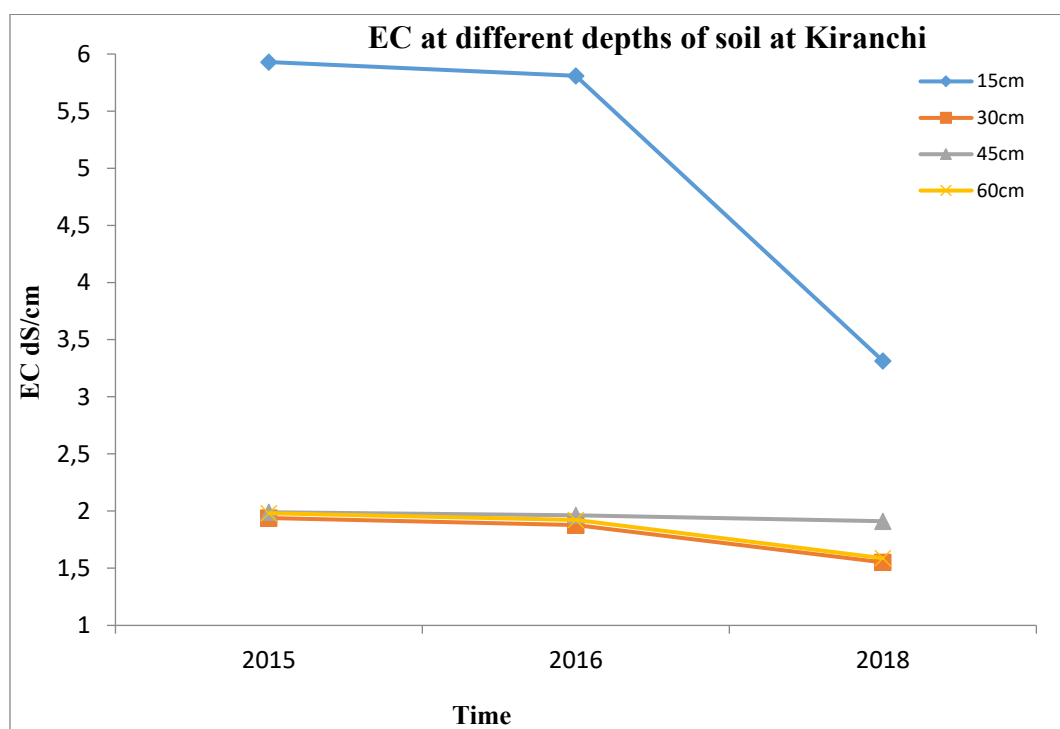
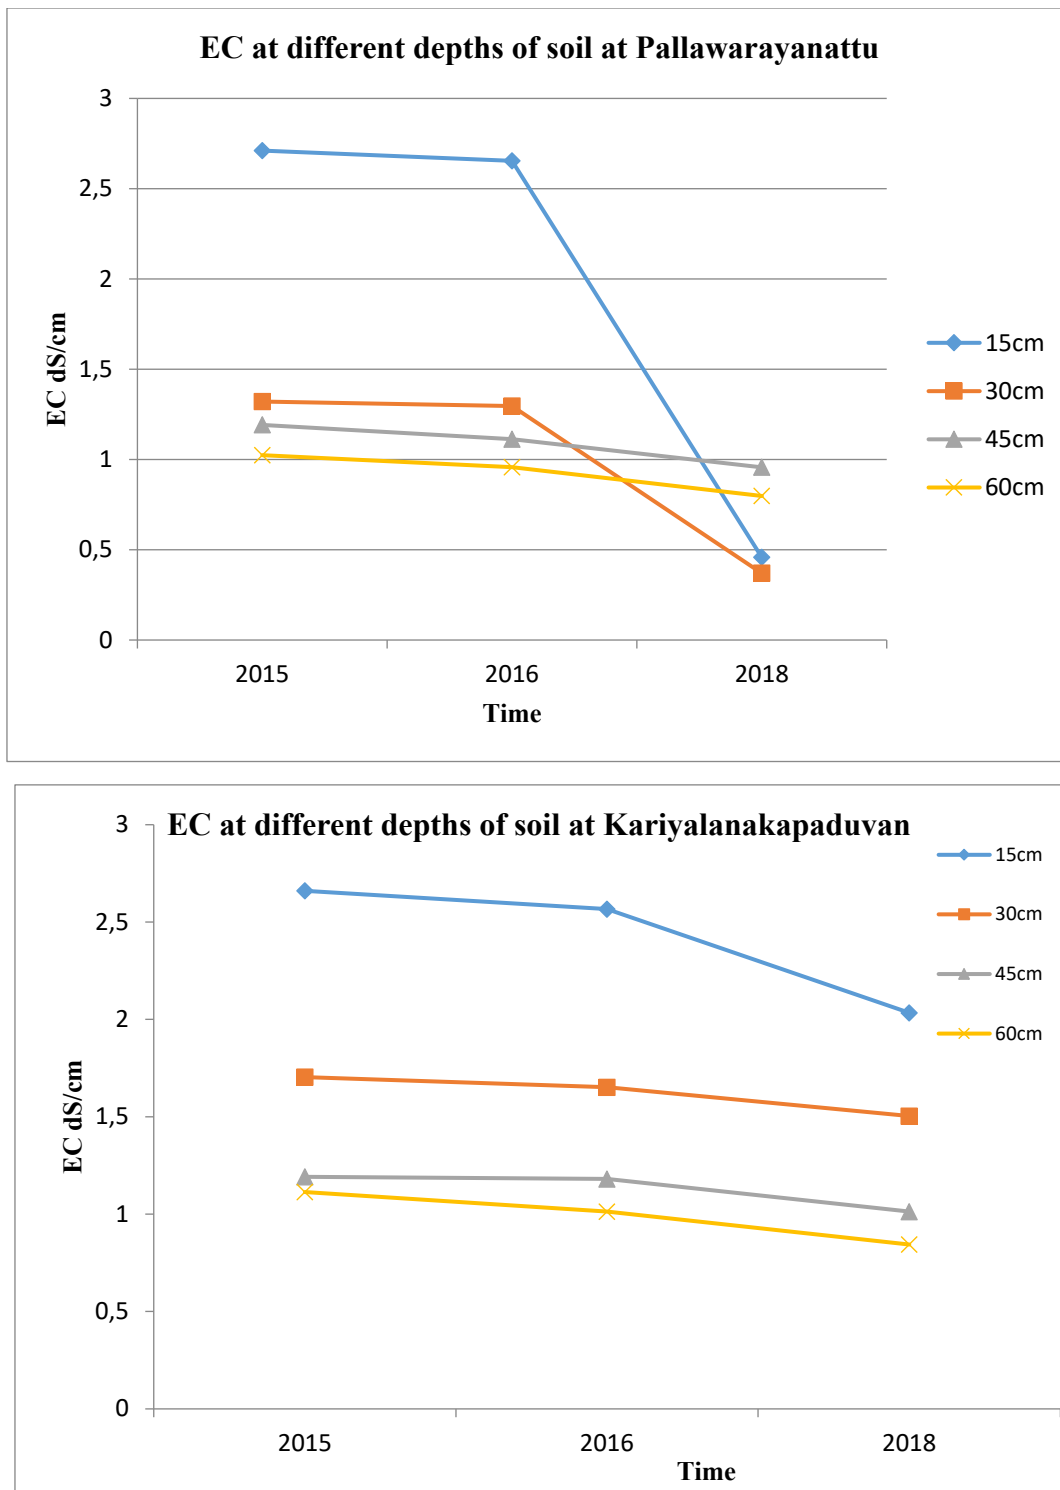
Figure III: Changes of soil EC with different soil depths at three selected locations

The above Figure (Fig. III) shows the variation of EC with different depths of soil in 2015, 2016 and 2018 of the selected locations. In 2016, a small reduction in the EC mean value observed, when compared to 2015. In 2018, a considerable reduction in the EC value was observed. In 2018, at 15cm dept, the EC value ranged from 0.458 – 3.315 and at 30cm depth, it varied from 0.37 – 1.552 and 45cm depth it was 0.957 – 1.911 and at 60cm depth it was 0.798 – 1.588. The improvement of EC was clearly indicated in 2018, due to the effect of bund. Shamsun Naher et.al, 2017, stated that in Bangladesh, the electrical conductivity values of salinity

affected soils varied from 1.50 to 35.90 dS/cm. Osman Ardahanlioglu et.al, 2002, pointed out that in Turey, the mean value of EC of salt affected soil at 0 – 30cm depth was 39.30 ± 20.3 dS/cm, at 30 – 60cm depth it was 37.80 ± 18.6 dS/cm. Therefore, the observed result was lesser than the referred values in 2018. The reduction of EC mean values can be due to the effect of sea water intrusion bund.

According to Paul & Rashid, (2017) and Weaver and Crist (1922), in salinity intruded soils, the electrical resistance increases from the surface to a depth of 2–4 feet (60–120 cm). The hardpan layer underlies much of this area of low rainfall at depths varying from 15 inches to 3 feet. When comparing the mean values of EC in 2015 at different depths revealed that, in 2016 and 2018, the soil EC indicated non saline condition at three selected locations.
